Waldo Canyon Post Fire Restoration

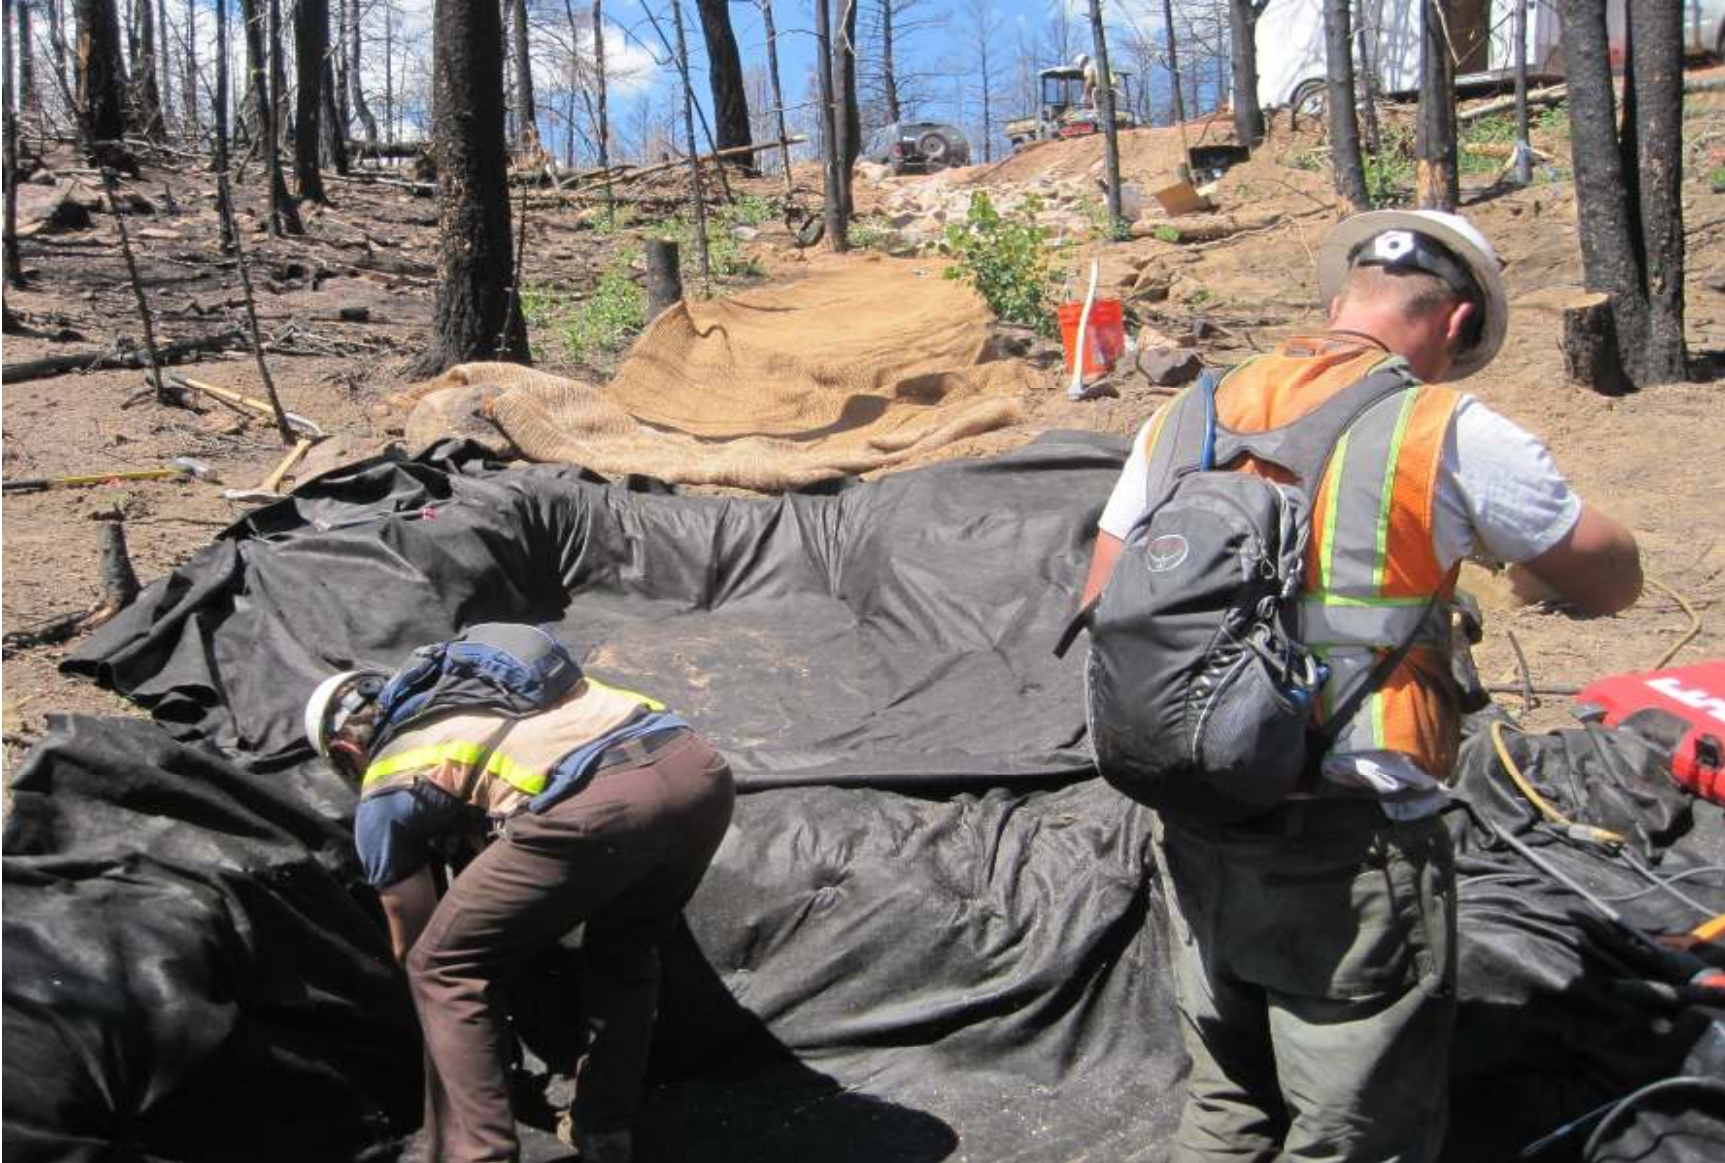
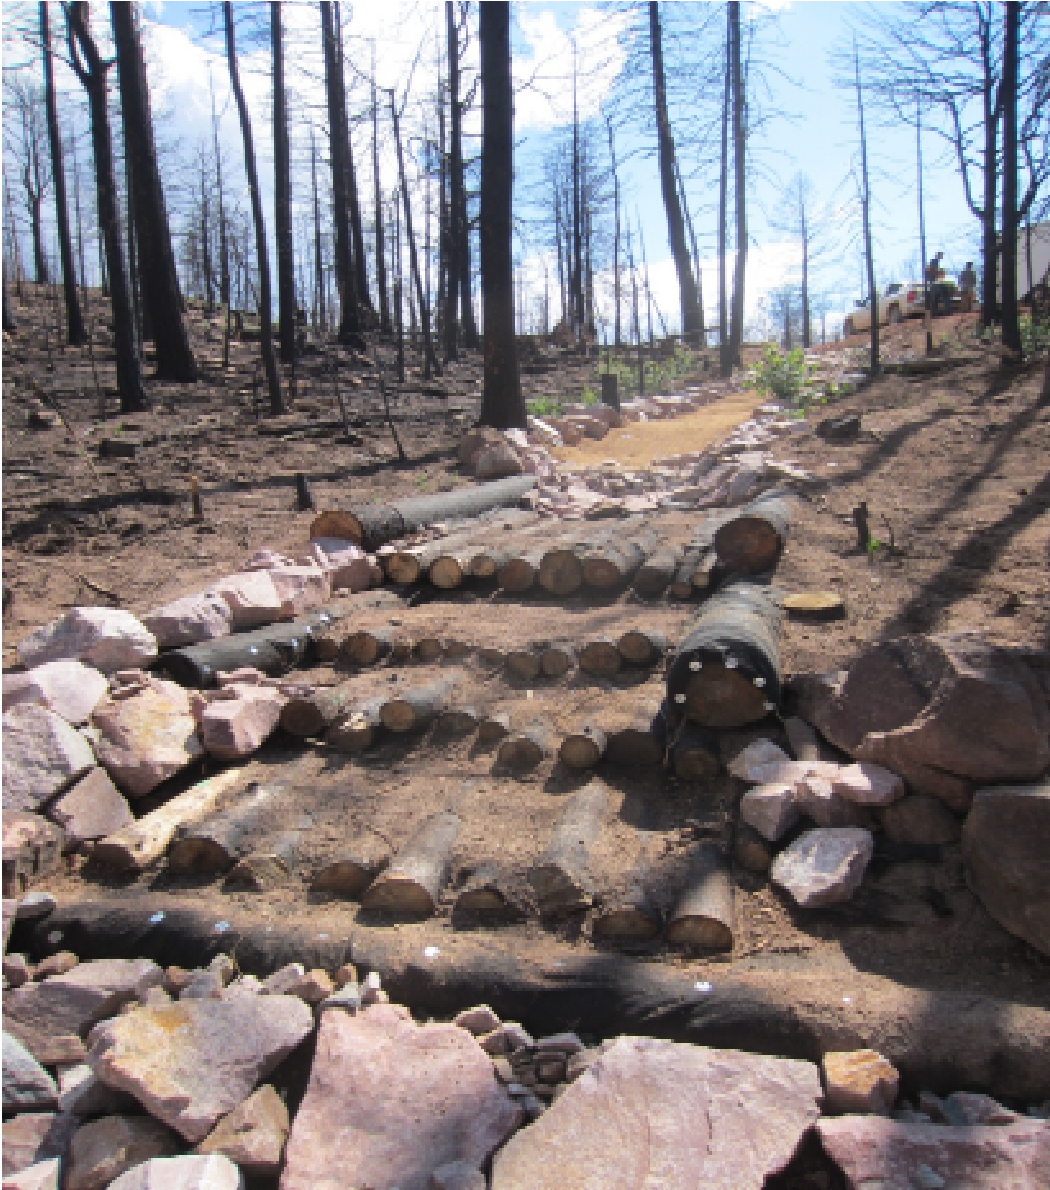
-Main Channel Flows

-Maintaining stream patterns in place

-End result is that each transition zone flows into the next leading structure.

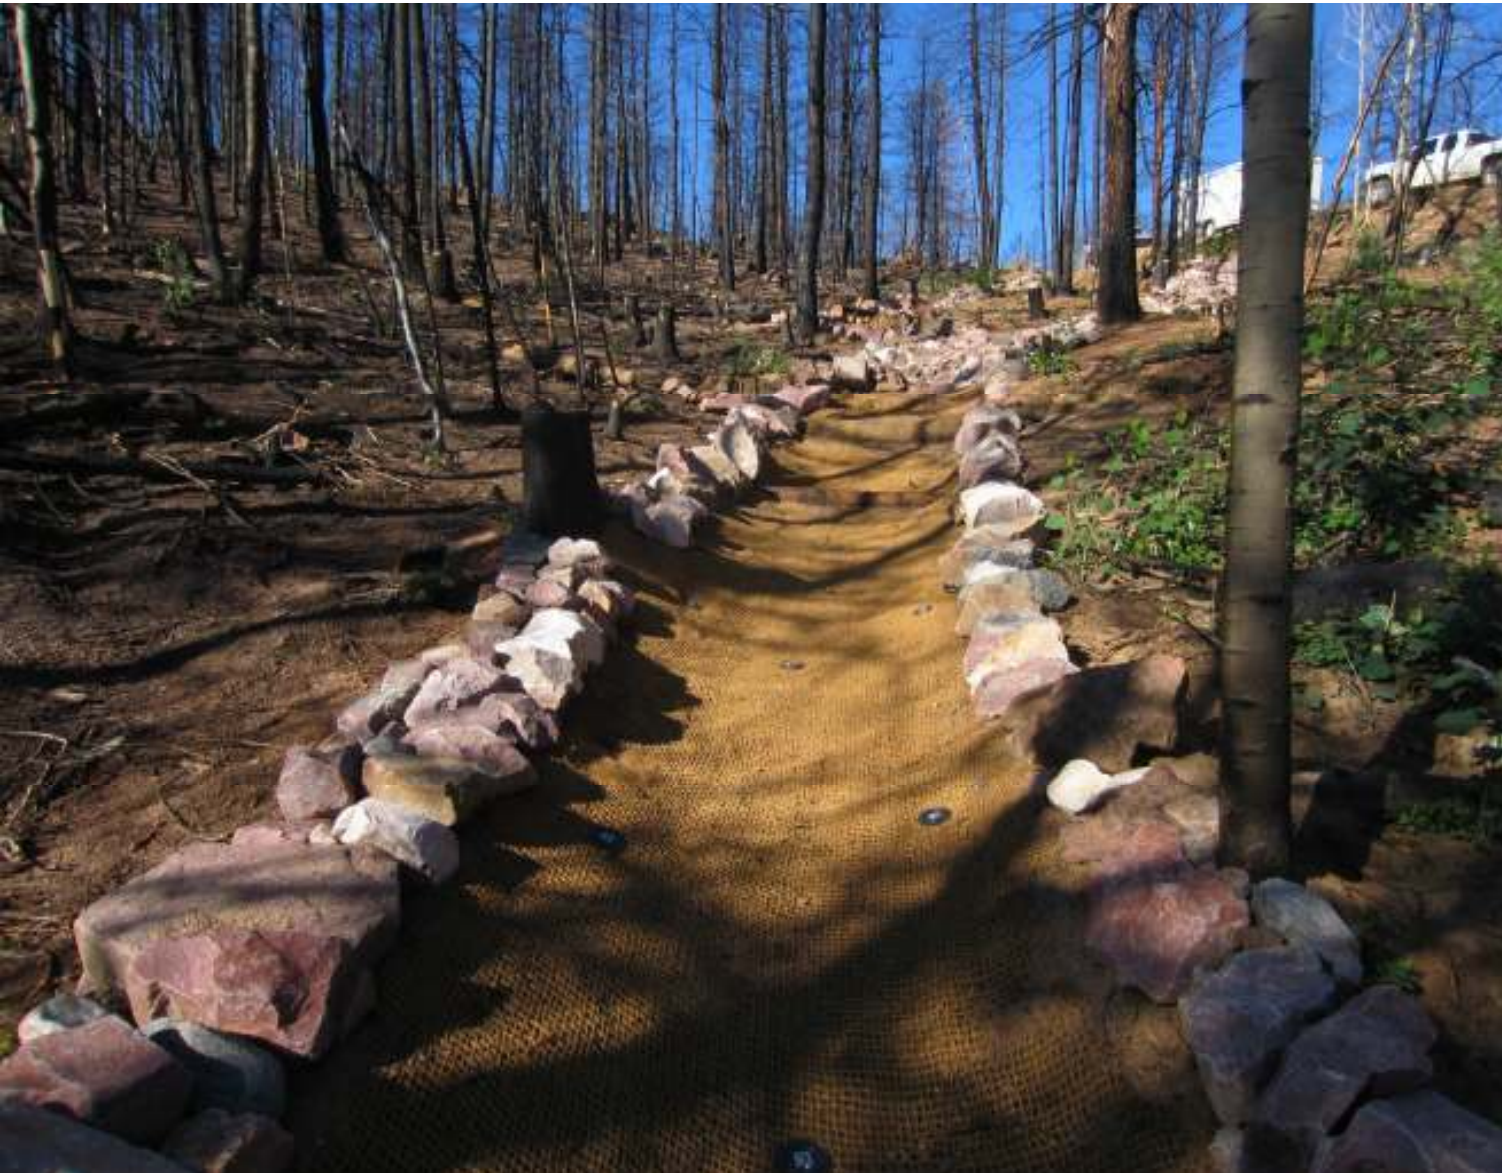
-Rock Lining edges added stability to the fabric and kept water from jumping out of the channel.

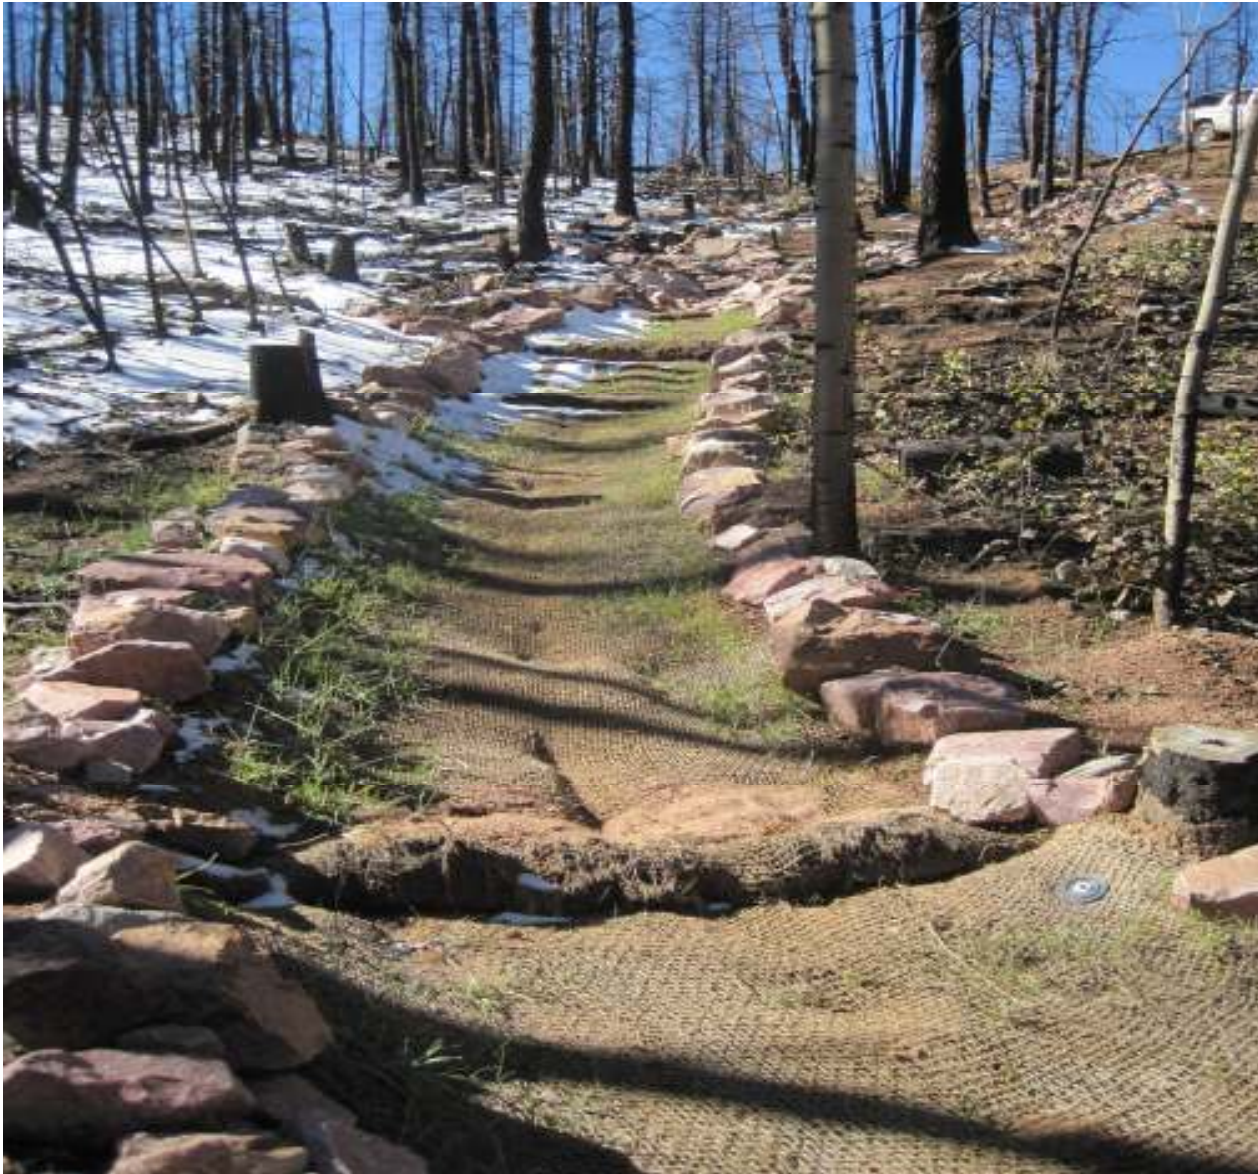
-Successful seeding underneath fabric added stability right away to areas with heavy flows.

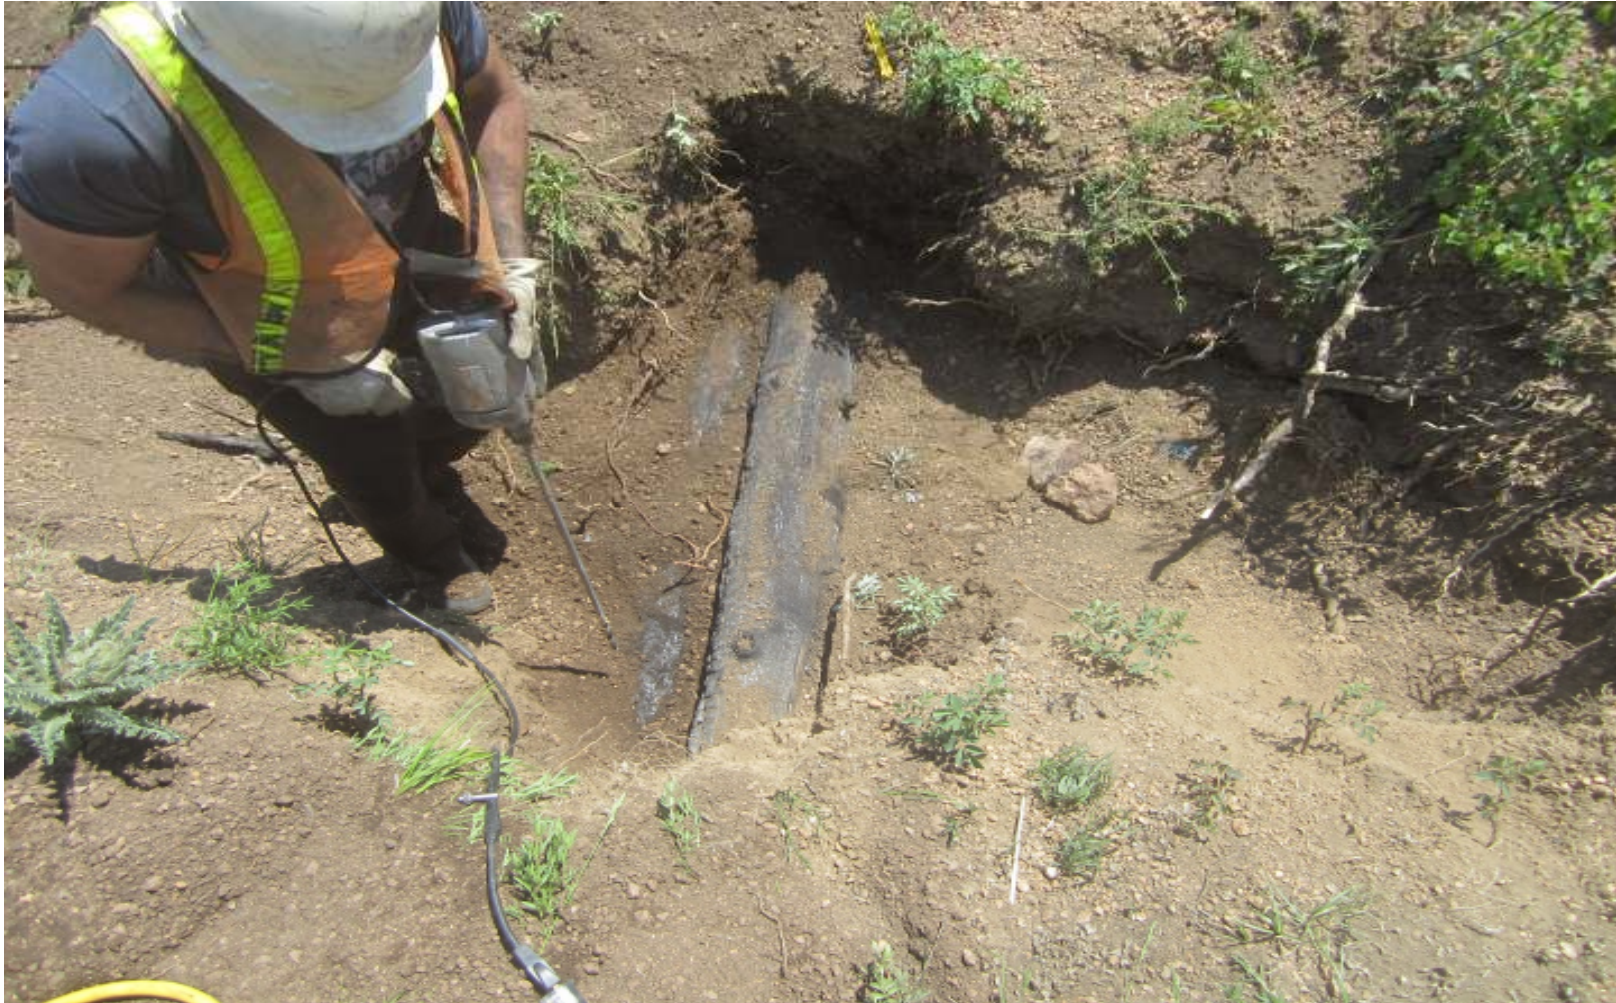
Adapted Checkdam Designs

We needed to Increase Stability

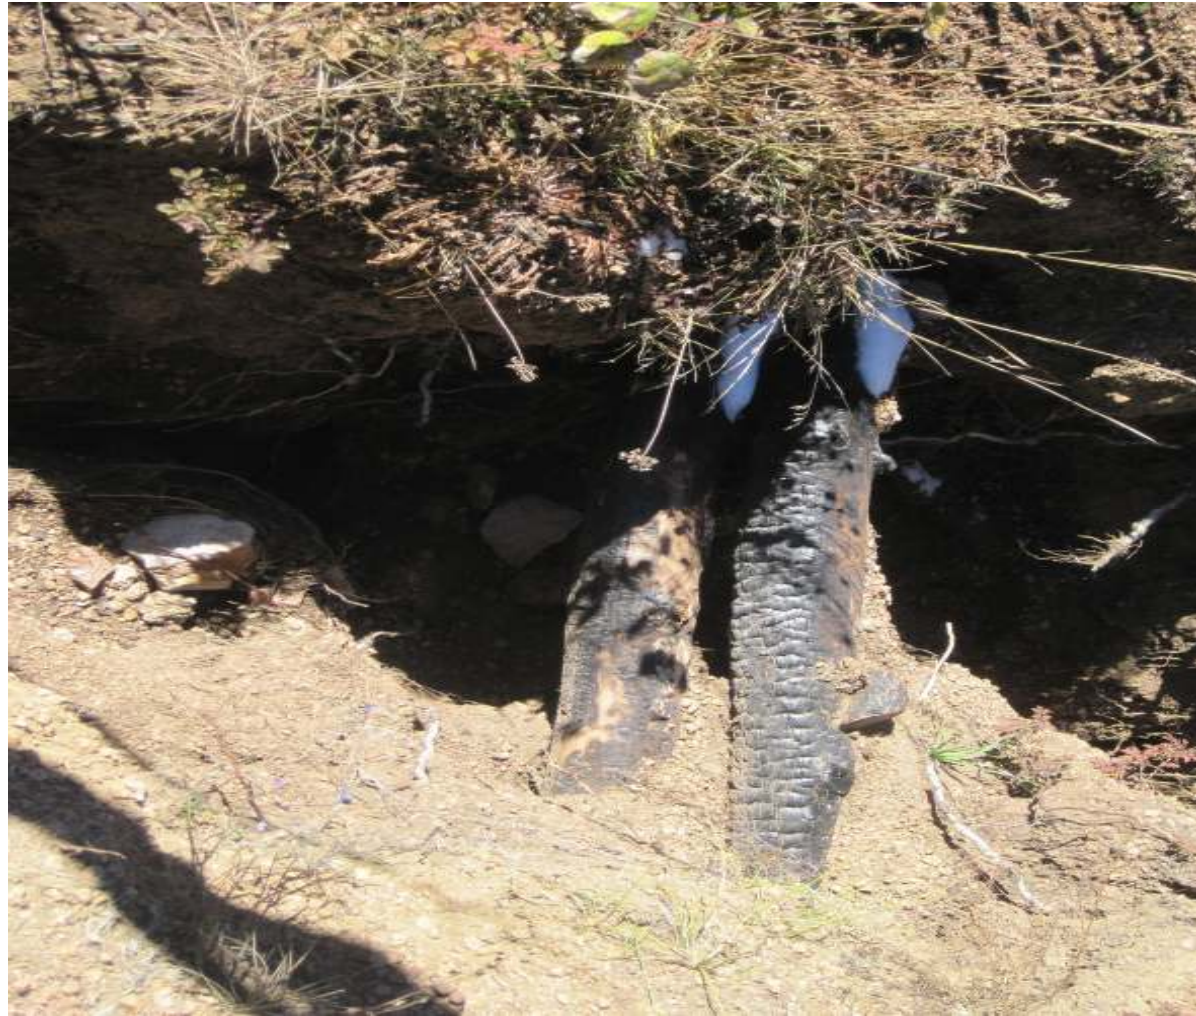
Increased rock armoring

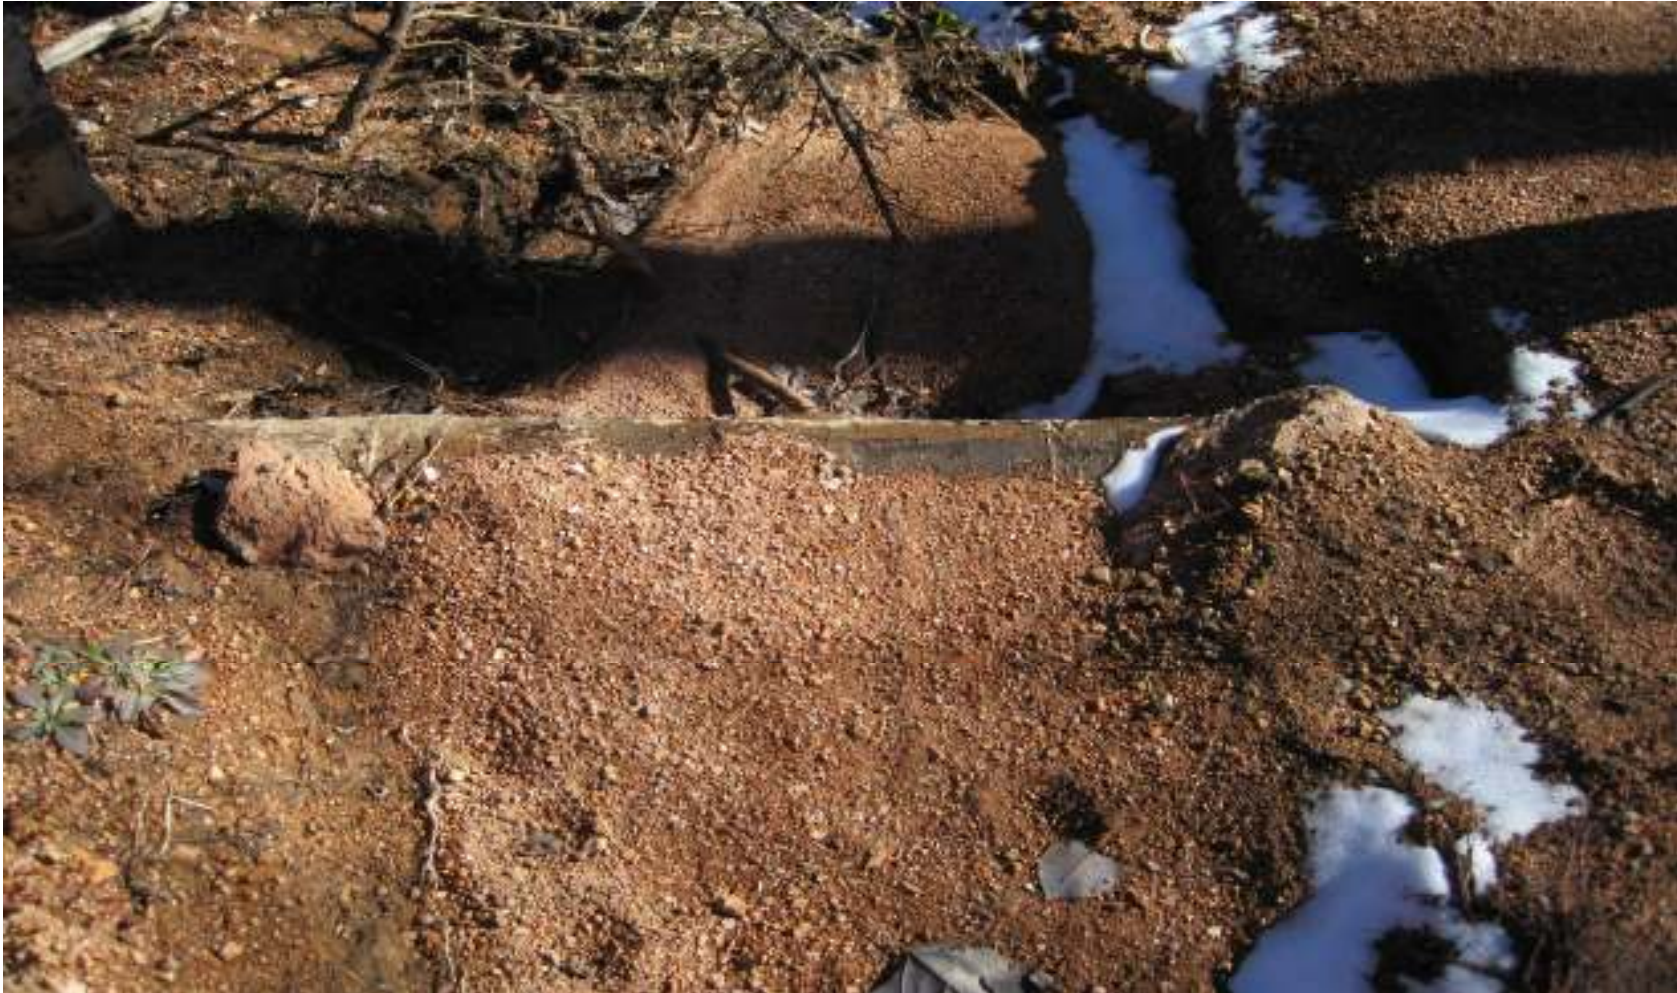
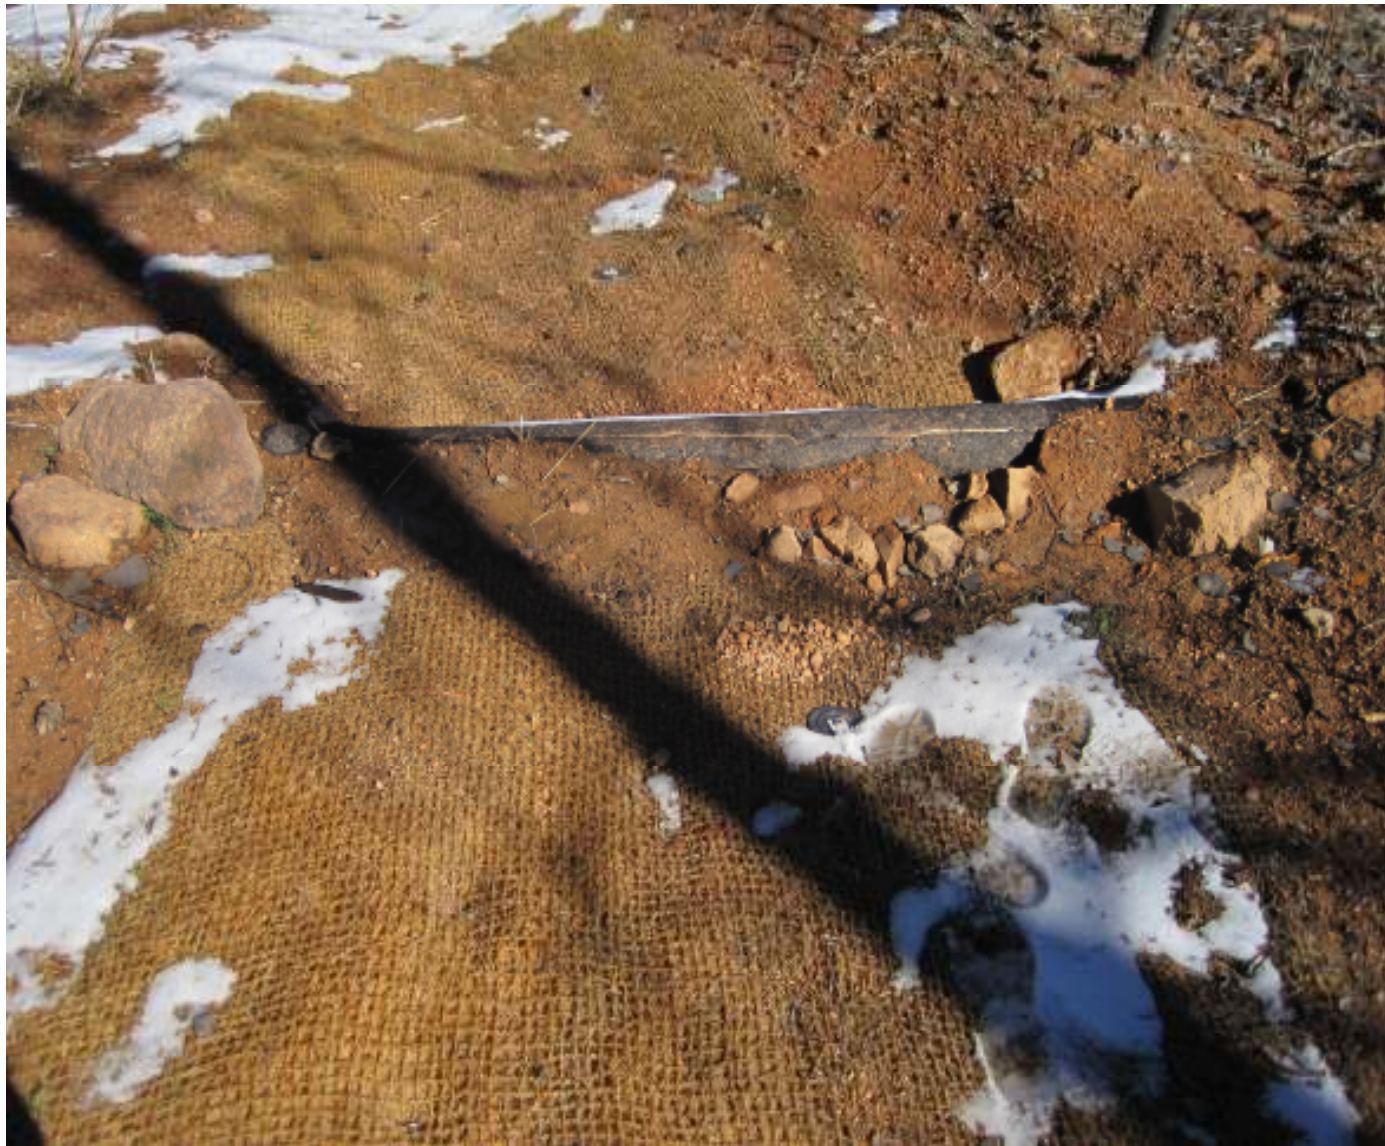
-Fabric with
checkdams
